INVESTIGATING VEGETATION INDUCED FAULTS ON POWER TRANSMISSION LINE; A CASE STUDY OF THE IRRUA-AUCHI-AGENEBODE 33KV TRANSMISSION LINE EDO STATE NIGERIA

Ajayi A, Osayi F.S, Jerome D.K and Omoregie A

Department of Electrical and Electronics Engineering,

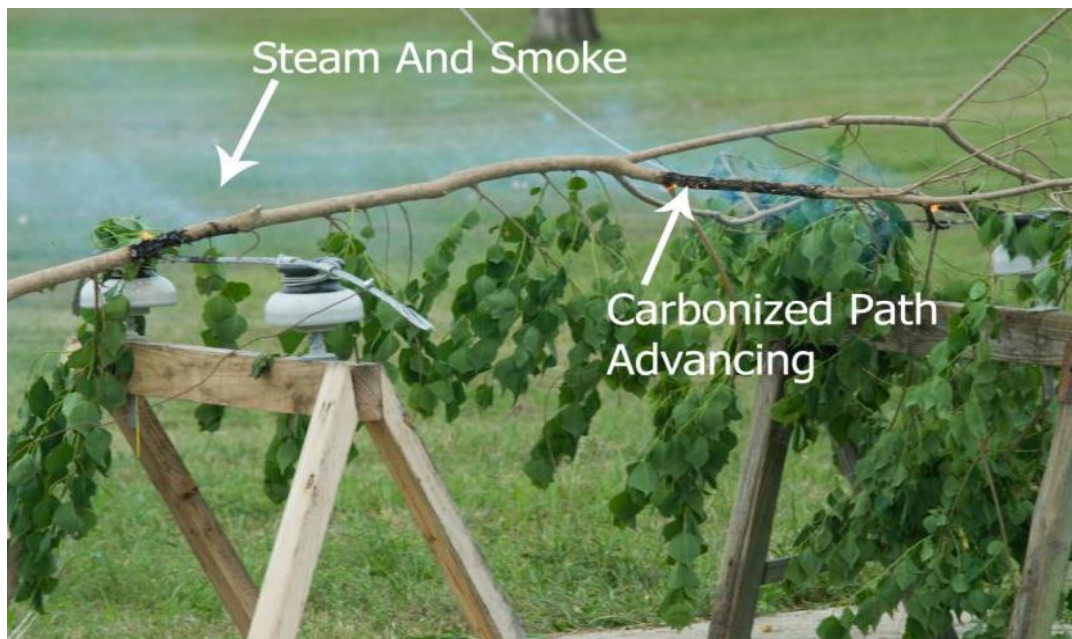
Figure 1.2: Carbonized Path Under Bark Producing Steam and Smoke

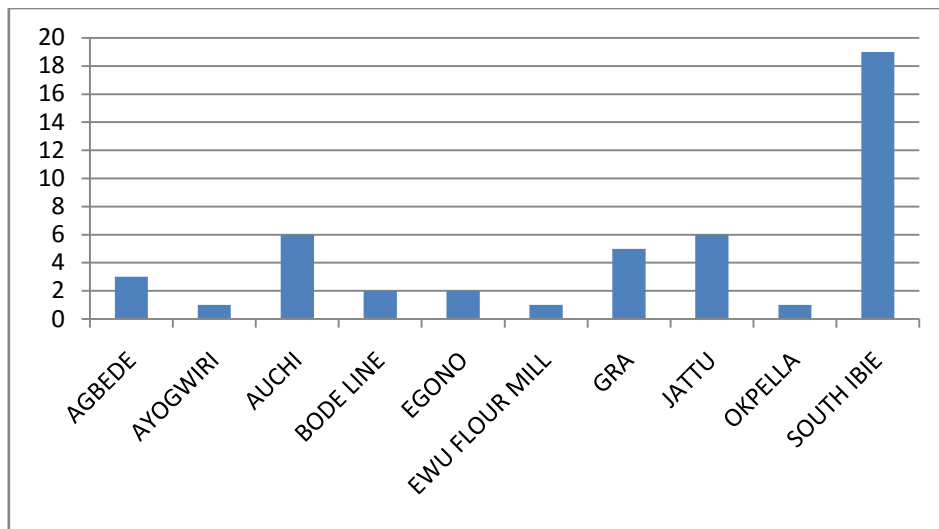
FIG 2.1 A graph of location against number of outages

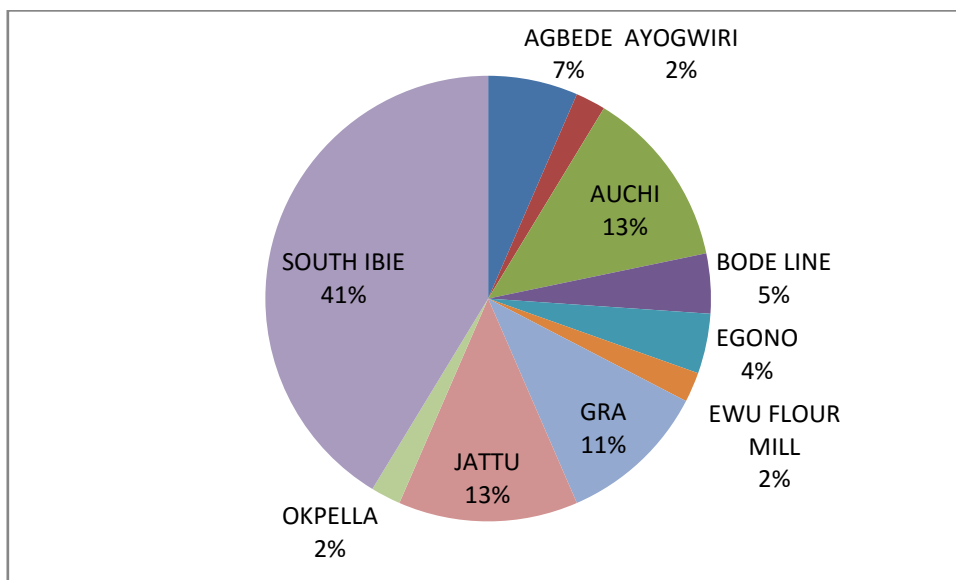
Fig 2.2: % FAULT /LOCATION

From the chart above ,it is shown that 41% of the vegetation induced fault on this line was caused on the south ibie section of the transmission line which was the highest during this period and the ayogwiri,ewu flour mill and the okpella section respectively are the least affected

- 1) Measuring and recording incipient vegetation-related outages should be encouraged
- 2) Hazard/danger tree identification and remediation programs will greatly improve reliability.
- 3) Eliminating or properly pruning overhanging branches especially in the south ibie section of the line will significantly improve reliability, particularly in storm conditions.
- 4) Maintaining a mandated minimum vegetation clearance (e.g. not closer than 18 inches) will likely impact overall reliability and will be cost effective.

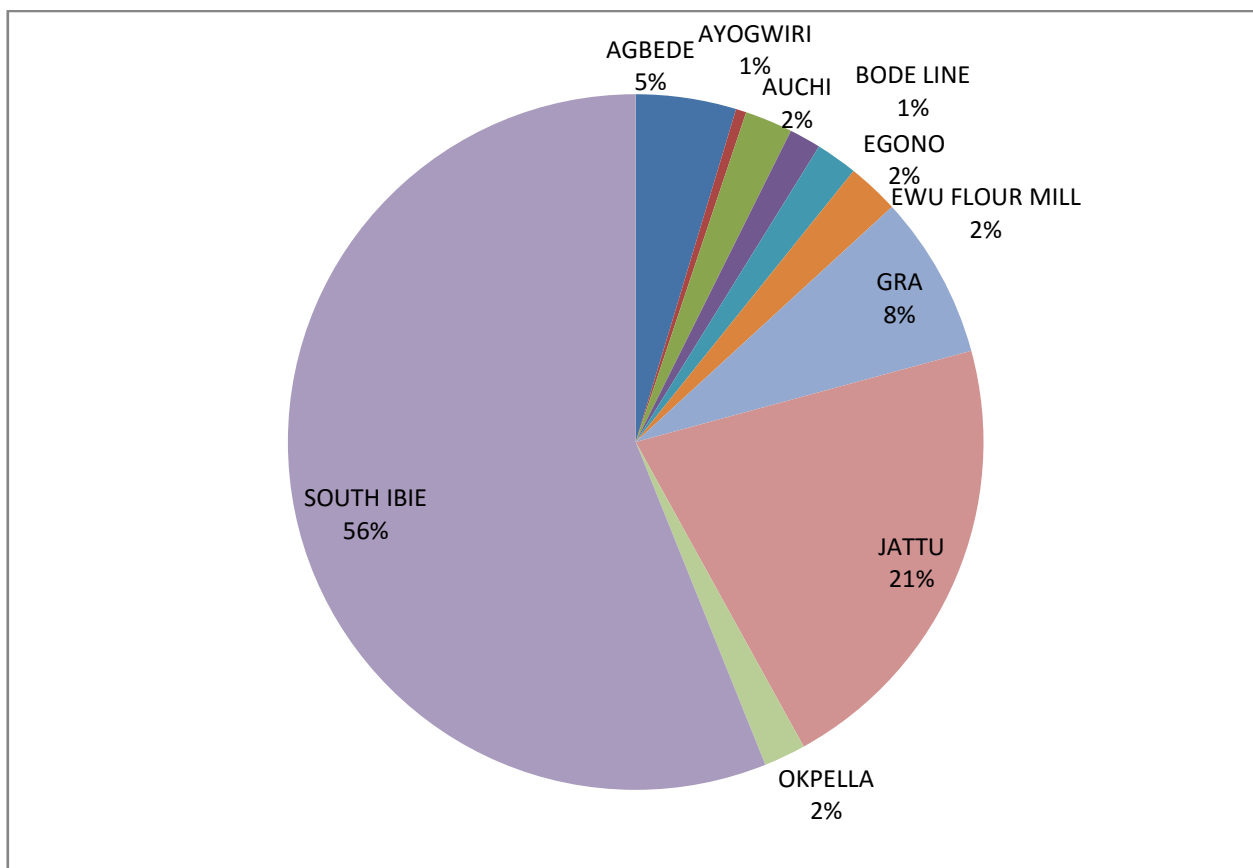
Fig2.3:% OUTAGE/LOCATION

From fig 2.3, it is shown that 56% ;more than half of the total outage experience by the cosumer on this line during the period under consideration was caused by fault on the south ibie section of the line, while the ayogwiri and bode line contribute the least;1% to the total outage experience on the line during the period.
