GLOBAL JOURNAL OF ADVANCED RESEARCH
(Scholarly Peer Review Publishing System)

EVALUATION OF STRUCTURAL CHANGES OF MICROSTRUCTURE AND PROPERTIES OF RAIL FASTENING SYSTEM SKL-12 AFTER LONG-TERM USAGE

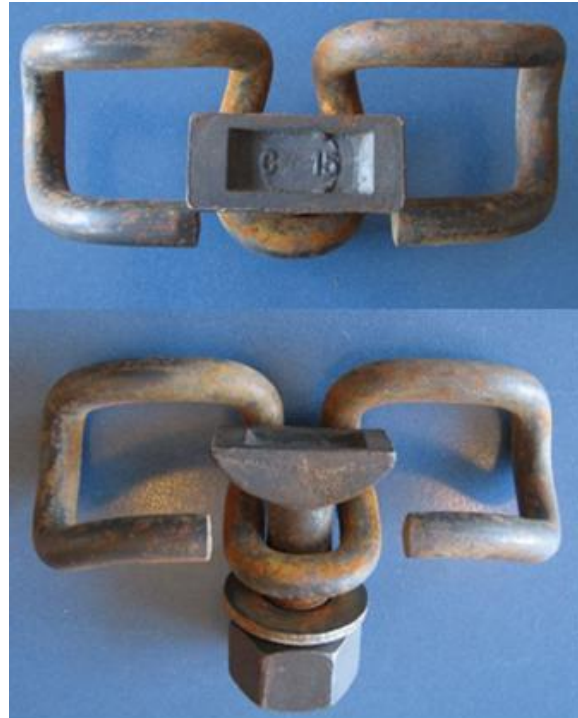
Fig 1: The investigated fasteners of the SKL 12system

For investigations was used a new elastic fastener SKL 12 delivered from the producer company FEZ as well as ca 40 years used fastener SKL 12 obtained during the repair work of the railway station in Gliwice (see Figure 1). Each of them was cut into 12 samples, which are then mounted and prepared for further studies. The samples were tested for the reason to compare the corresponding pair in terms of their microstructure and properties as well as changes occurred during long time usage under real conditions. The samples have been cut in the same adequate places in the horizontal and longitudinal direction, polished and then etched in 10% nital in room temperature.

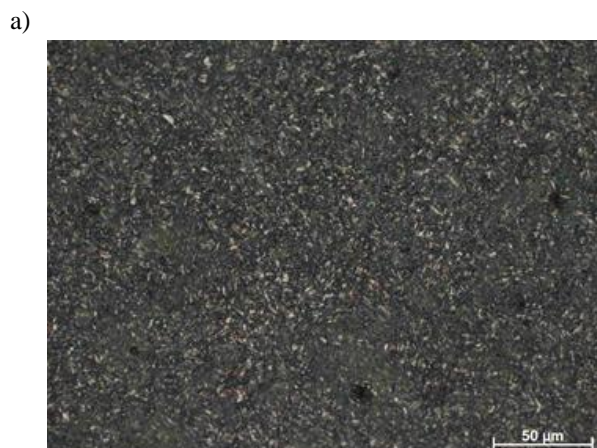
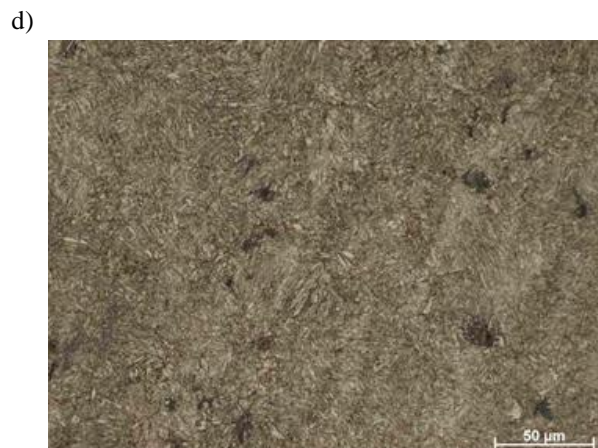
Fig 2: Microstructure of the non-used: a), c), e) and used b), d), f) fasteners of the SKL 12 system, depending on the sampling place and direction

- ❖ The results of the tests carried out by mind of optical microscopy show that the particle size of the non-used elastic SKL12 fastener reaches from 8 to 10 μm , whereas in the used elastic SKL12 fastener the grain size ranges from 10 to 12 μm , depending on the measurement place in the fastener,

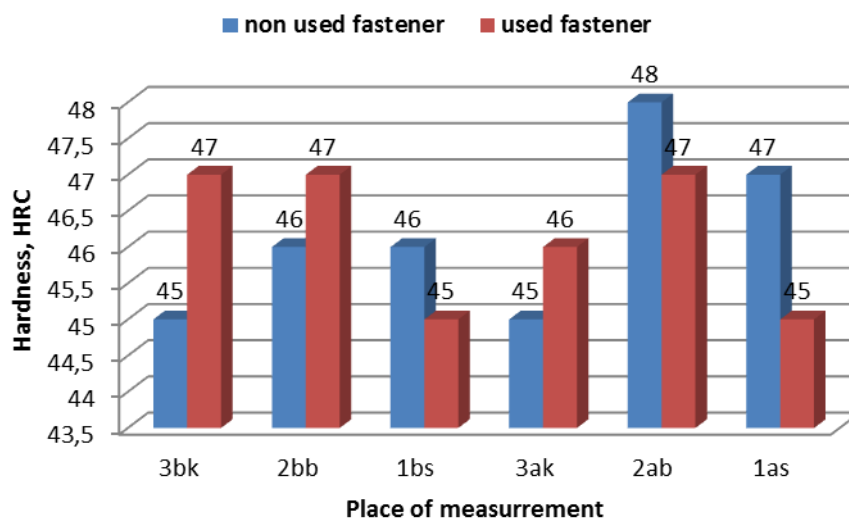
Fig 6: Hardness measurement results for the chosen places of the fasteners

Another study, which was obtained was the Rockwell hardness measurement. According to data from the production company the hardness value of the material should be in the range 42-46 HRC. Figure 6 presents the results obtained for each sample. According to this research, the average hardness of the non-used elastic SKL12 fastener is equal 48 HRC and in used element 45 HRC. Both values are within the established properties of the 50S2 steel, as the material for the SKL 12 fastening system. The analysis of the results reveals that the general hardness of the non-used paw and the used ones is close to each other, but with different distribution within the entire element. This is clearly visible in Figure 6.

- ❖ For the non-used elastic SKL 12 fastener the determined hardness is 48 HRC and for the used element 45 HRC, what is generally in the range of the allowed measurement error,
