INVESTIGATING VEGETATION INDUCED FAULTS ON POWER TRANSMISSION LINE; A CASE STUDY OF THE IRRUA-AUCHI-AGENEBODE 33KV TRANSMISSION LINE EDO STATE NIGERIA

Ajayi A, Osayi F.S, Jerome D.K and Omoregie A

Department of Electrical and Electronics Engineering,

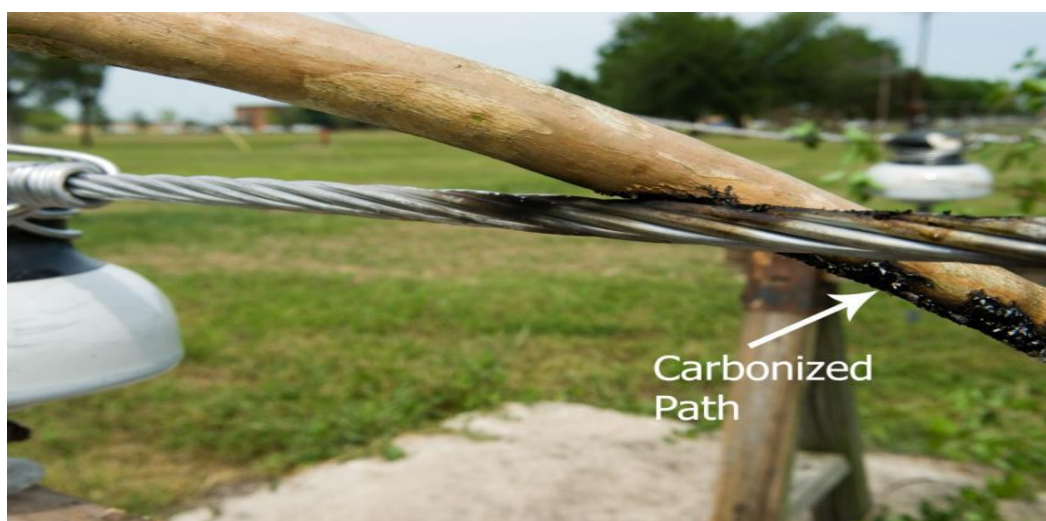
Figure 1.0: Formation of Arc between Lines

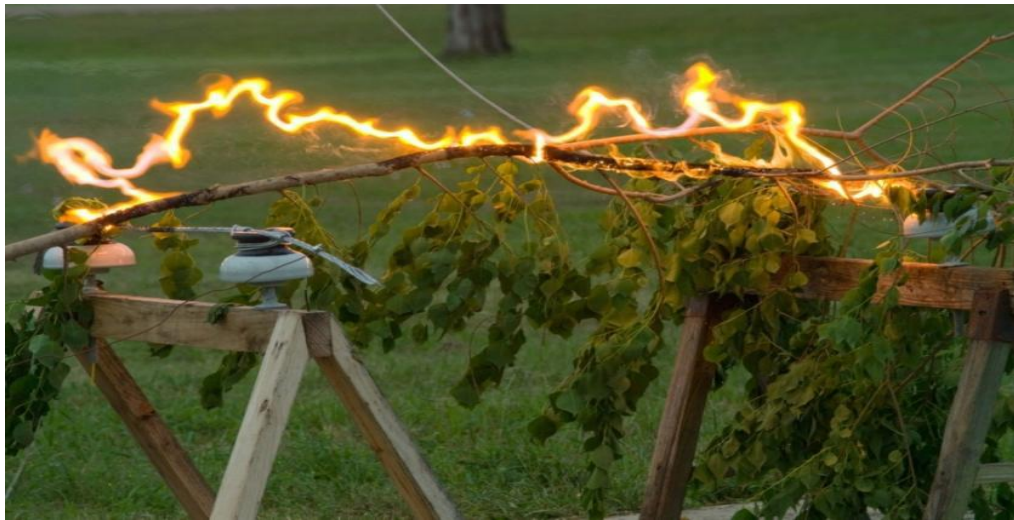
If, on the other hand, the voltage gradient is sufficient to generate localized dry band arcing, a conductive fault track develops. This charring results in the fault pathway becoming increasingly conductive. If the charred pathway reduces impedance faster than internal resistance, heating drives off moisture and increases impedance and the gap is bridged, resulting in a high-current fault and subsequent interruption (Daily,1999).

Figure 1.3: Formation of Arc Between Lines
